# *Encompass Inspections LLC*

## Property Inspection Report

1234 ABC Ave, Twin Cities MN, ?????  
Inspection prepared for: John Doe & Jane Doe  
Agent: Support - Home Inspector Pro

Inspection Date: 1/1/2008 Time: 11:30  
Age: 1945 Size: 2400

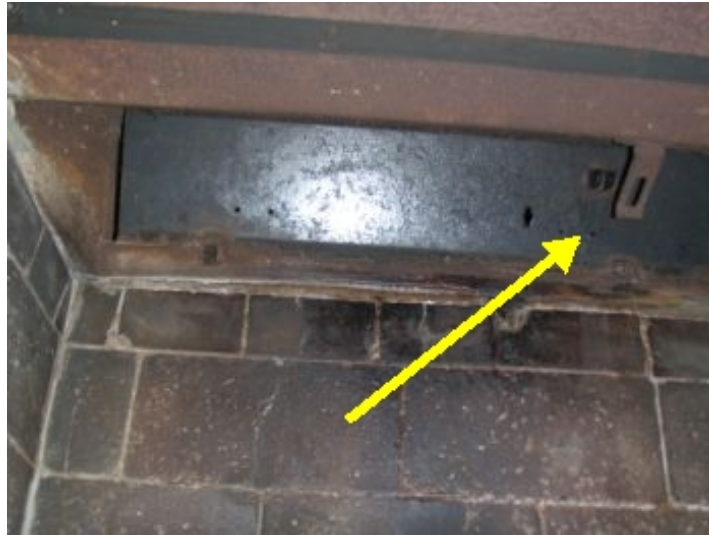
### 11. Fireplace

- The fireplace damper is damaged and not functional on both fireplaces. The lever will not open or close the damper correctly. Do not attempt to start a fire until corrected.

The fireplace damper is damaged and not functional on both fireplaces. The lever will not open or close the damper correctly. Do not attempt to start a fire until corrected.

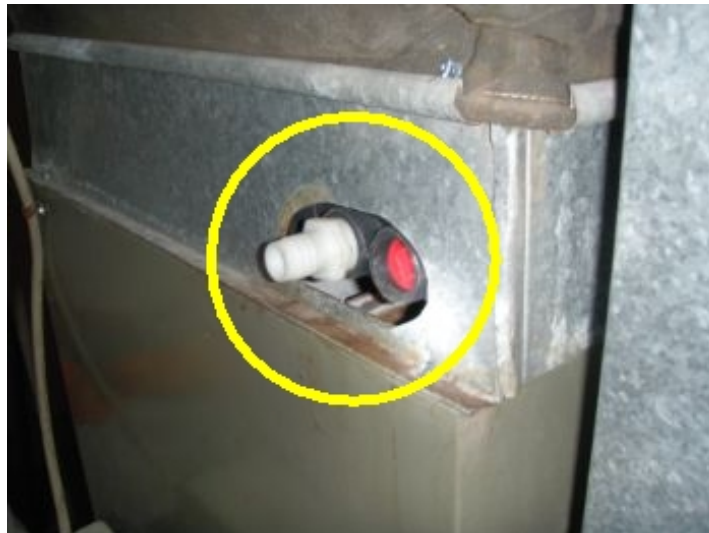
#### 4. AC Compress Condition

- Appeared functional at the time of inspection.
- Exterior refrigerant lines wall penetration needs repair and sealing/caulking.
- **Condensation drain line is not hooked up and therefore water will drain down the side of the furnace when A/C unit is used. I recommend to hire a licensed HVAC contractor to install the proper condensate drain lines**

Condensation drain line is not hooked up and therefore water will drain down the side of the furnace when A/C unit is used. I recommend to hire a licensed HVAC contractor to install the proper condensate drain lines

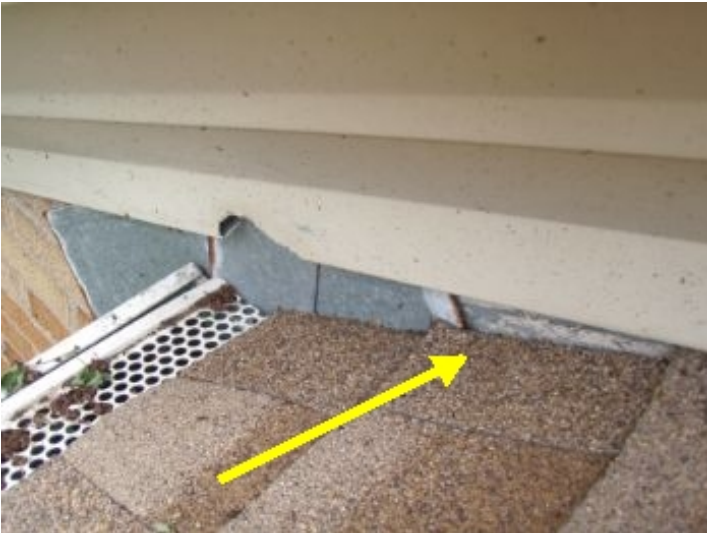
Poor roof flashing- it appears there are no kick out flashings installed. I recommend to hire a licensed contractor to install proper kick out flashings as needed

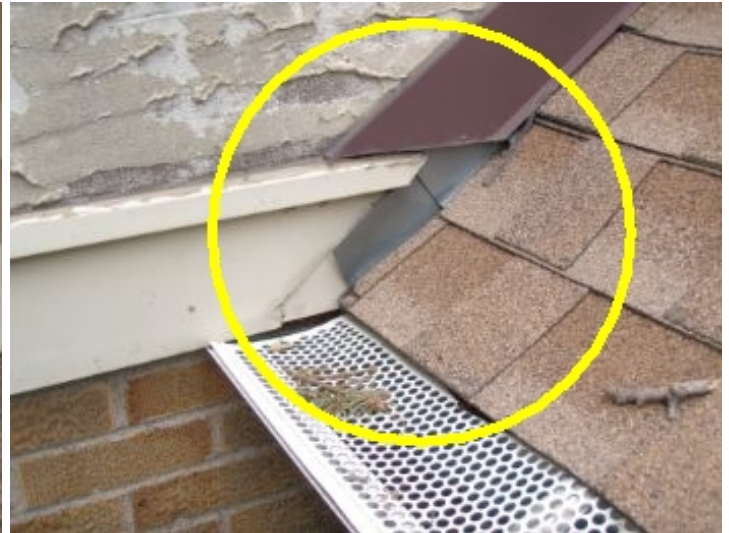
Poor roof flashing- it appears there are no kick out flashings installed. I recommend to hire a licensed contractor to install proper kick out flashings as needed

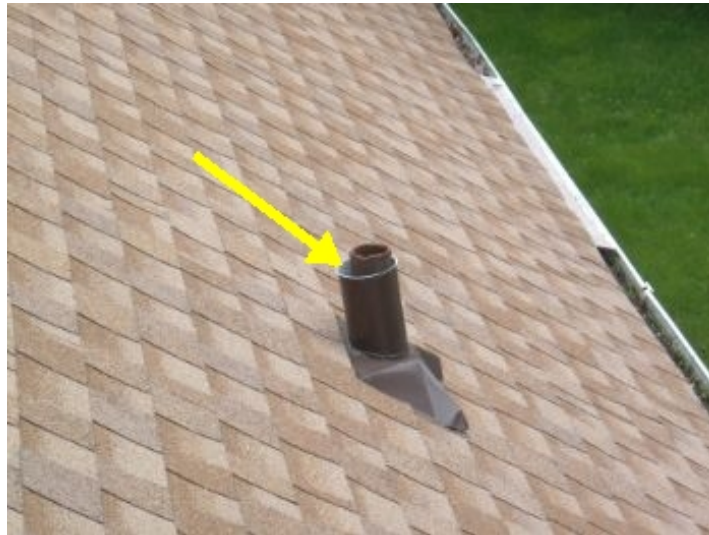
4. Vent Caps

The vent cap is missing. I recommend replacing both of the plumbing vent caps.

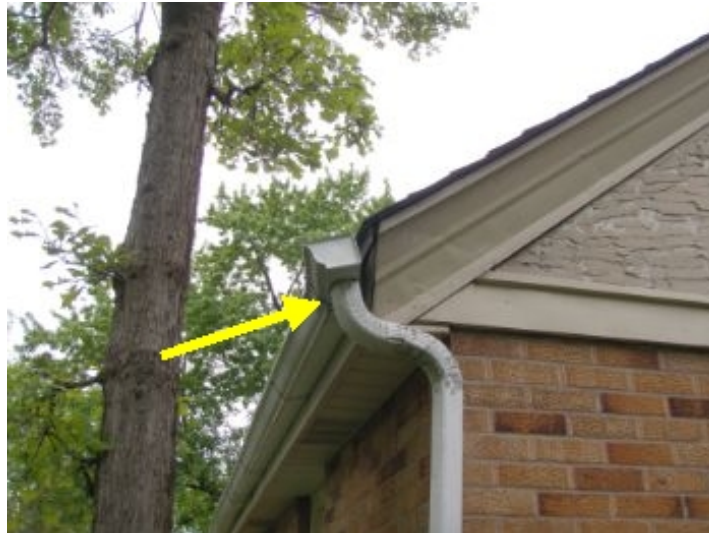
### 5. Gutter

some of the downspouts were not connected at time of inspection.

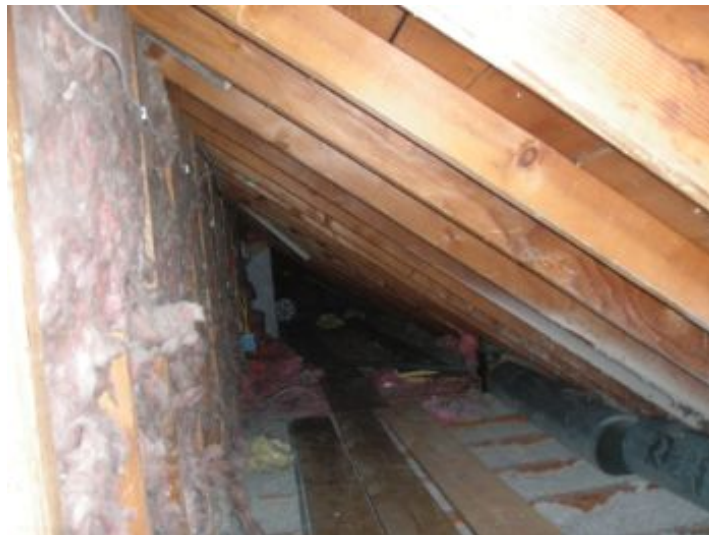
5. Insulation Condition

**IMPROVE: Add insulation to improve to R-49 -- The Department of Energy R-Value recommendation for attic insulation in this area.**

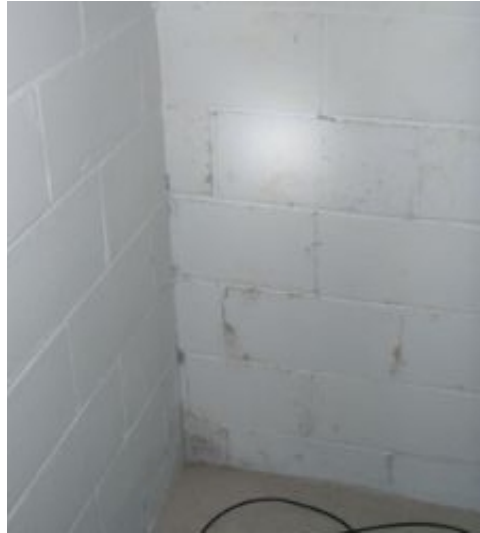
## 1. Walls

Evidence of past water penetration observed. on the rear corner of the basement near the furnace and under the front entry

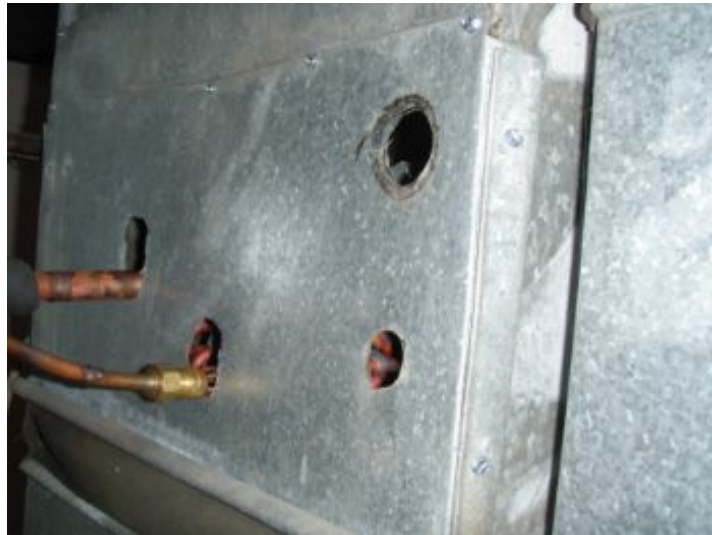
### 14. Basement Ductwork

Recommend sealing all gaps, cracks and holes in the HVAC duct system for increased efficiency and lower energy bills.
